HYUNDAI Technical Service Bulletin

Group	CLIMATE CONTROL
Number	07-97-001
Date	APRIL, 2007
Model	2007 ENTOURAGE

Subject
2007 ENTOURAGE A/C COMPRESSOR DISC AND HUB REPLACEMENT

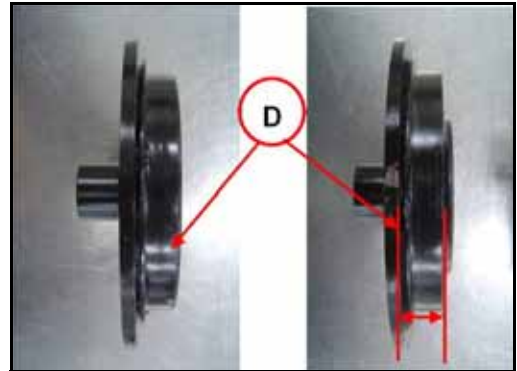
NOTE: Rubber thickness on new part has been increased.

6. Install new disc & hub assembly (D).
