HYUNDAI Technical Service Bulletin

Group	BODY
Number	07-60-001
Date	FEBRUARY, 2007
Model	2007 ENTOURAGE

Subject
DRIVER SEAT LUMBAR SUPPORT LINKAGE REPOSITIONING PROCEDURE

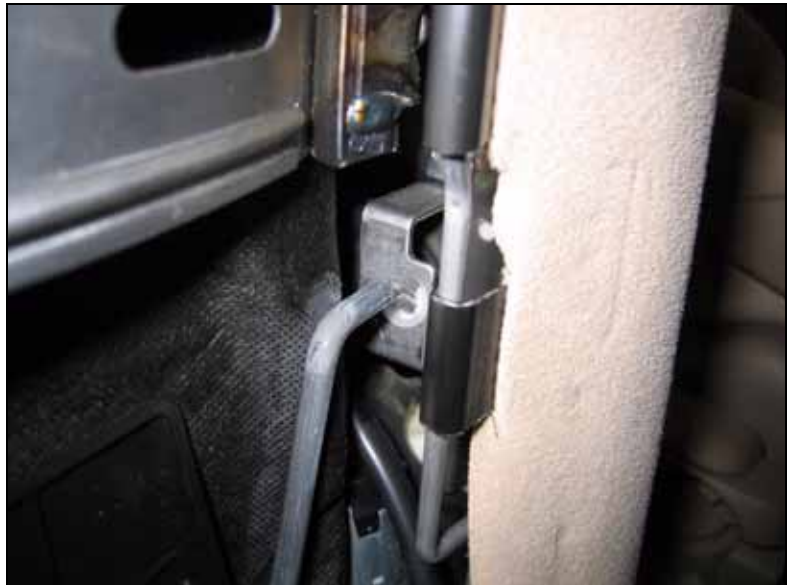
5. Verify the positioning of the lumbar control linkage into the pivot bracket on the right side of the seat back with the plastic bushing inserted in place.

- This photo shows the lumbar control linkage separated from the pivot bracket.
