HYUNDAI Technical Service Bulletin

Group	CHASSIS
Number	06-50-015
Date	DECEMBER, 2006
Model	ENTOURAGE

Subject	FRONT STRUT NOISE
---------	--------------------------

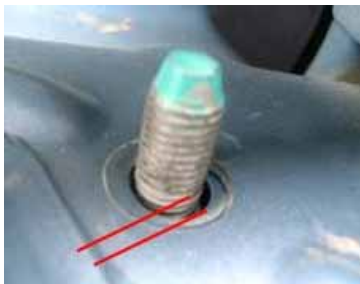
Some ENTOURAGE vehicles may exhibit a "clicking/ratcheting" noise from the front struts while driving on a bumpy road. This noise may be caused by an interference between the insulator bolts and the fender apron panel resulting from improperly seated strut insulator bolts and/or interference from a spot weld or sealant as shown.

Uneven gap

To correct this condition, follow the service procedure provided in this bulletin.

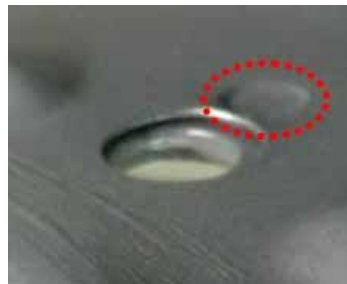
Spot weld

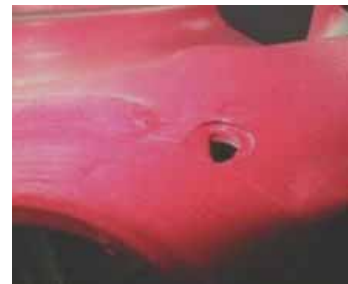
Sealant
