HYUNDAI Technical Service Bulletin

Group	BODY
Number	07-60-002
Date	MAY, 2007
Model	2007 ENTOURAGE

Subject	REAR SPOILER PAD REPLACEMENT
---------	-------------------------------------

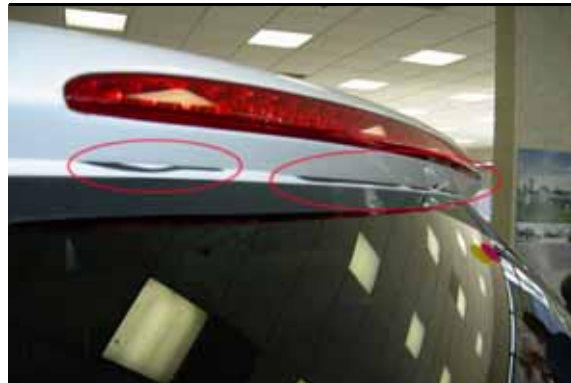
Portions of the rear spoiler pads may protrude through the gap between the spoiler and tail gate on some 2007 MY Entourage vehicles.
