HYUNDAI Technical Service Bulletin

Group	CLIMATE CONTROL
Number	07-97-001
Date	APRIL, 2007
Model	2007 ENTOURAGE

Subject
2007 ENTOURAGE A/C COMPRESSOR DISC AND HUB REPLACEMENT

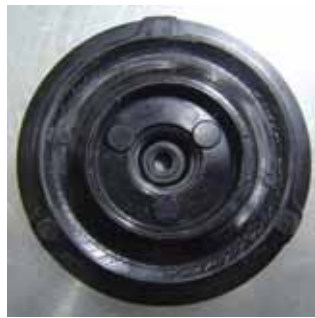
Some 2007 MY Entourage vehicles may experience an abnormal tapping noise during A/C compressor use. Installation of the new Disc & Hub Assembly will reduce the transmitted noise.

PART NAME	PART NUMBER	
	Previous	New
Disc & Hub Assembly	97644-4D900	97644-4D900FFF
